[Docket No. 97-SW-60-AD]

Airworthiness Directives; Sikorsky Aircraft-Manufactured Model CH-54A Helicopters

ACTION: Notice of proposed rulemaking (NPRM).

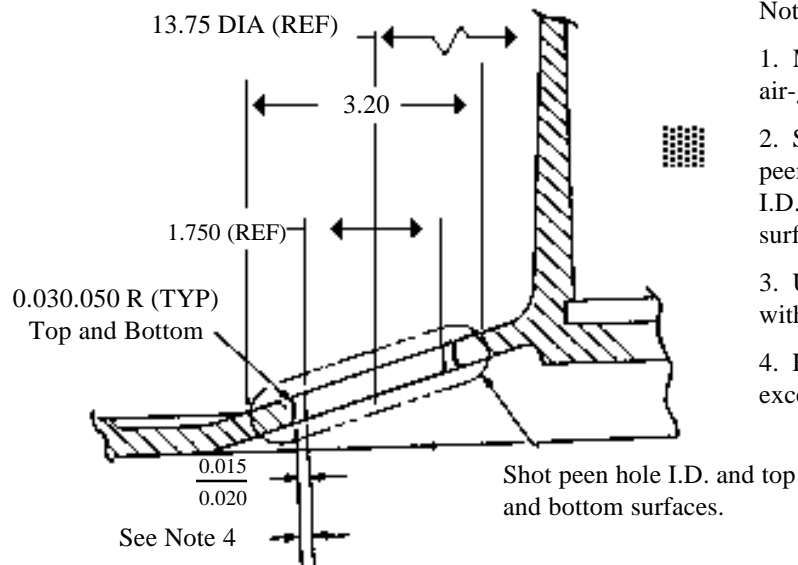
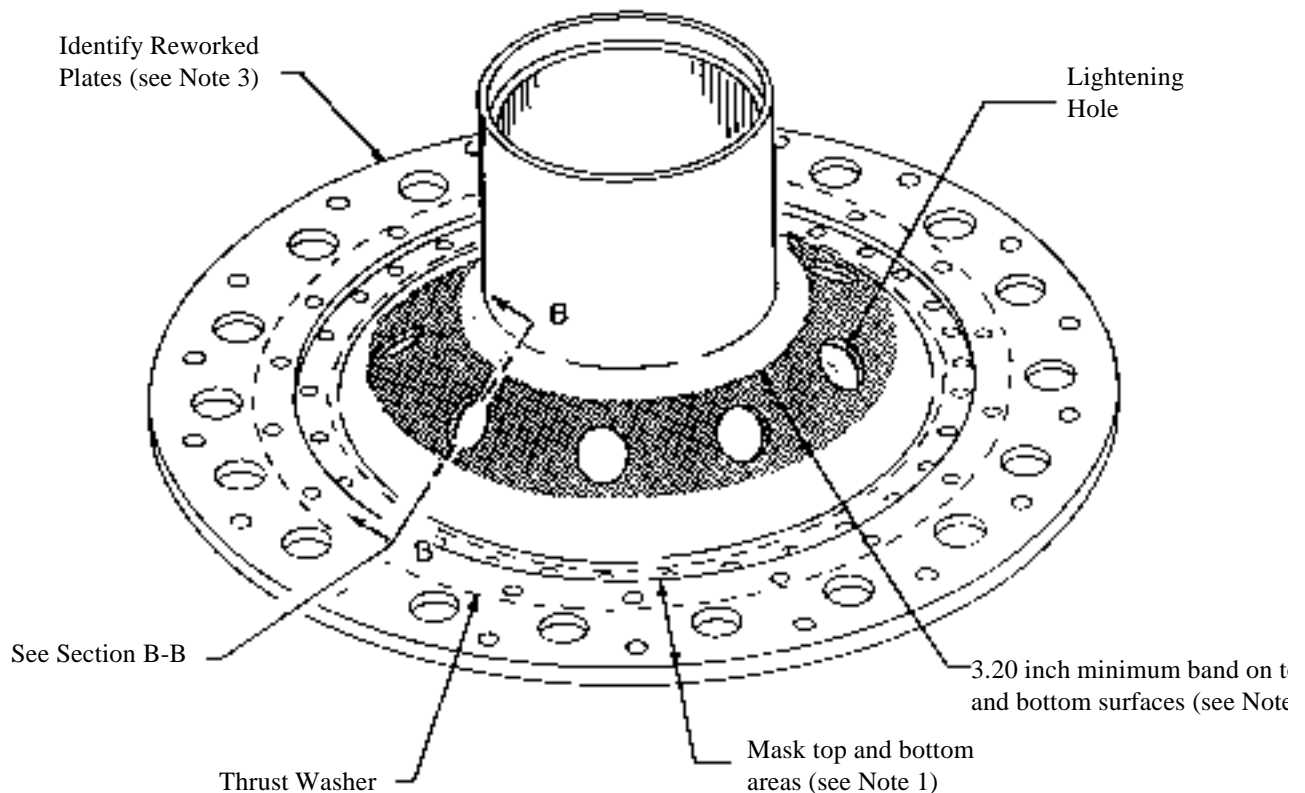
Rework of Second Stage
Lower Planetary Plate (6435-20229-102)
Figure 1

To prevent failure of the second stage lower planetary plate (plate), P/N 6435-20229-102, due to fatigue cracking, which could lead to failure of the main gearbox, failure of the drive system, and subsequent loss of control of the helicopter, accomplish the following:

(a) On or before accumulating 1,300 hours time-in-service (TIS) conduct a fluorescent magnetic particle inspection of the plate, P/N 6435-20229-102, in the circumferential and longitudinal directions using the wet continuous method. Pay particular attention to the area around the 9 lightening holes.

(i) Locate the center of each 1.750 inch-diameter lightning hole and machine holes 0.015 to 0.020 oversize on a side (0.030 to 0.040 diameter oversize). Machined surface roughness must not exceed 63 microinches AA rating (see Figure 1).

(ii) Radius each hole 0.030 to 0.050 inches on each edge as shown in Figure 1.

(iii) Mask the top and bottom surfaces of the plate to expose 3.20 inch minimum width circumferential band as shown in Figure 1.

(viii) Identify the reworked plate by adding “TS-107” after the part number using a low-stress depth-controlled impression-stamp with a full fillet depth of not more than 0.003 inch (see Figure 1).

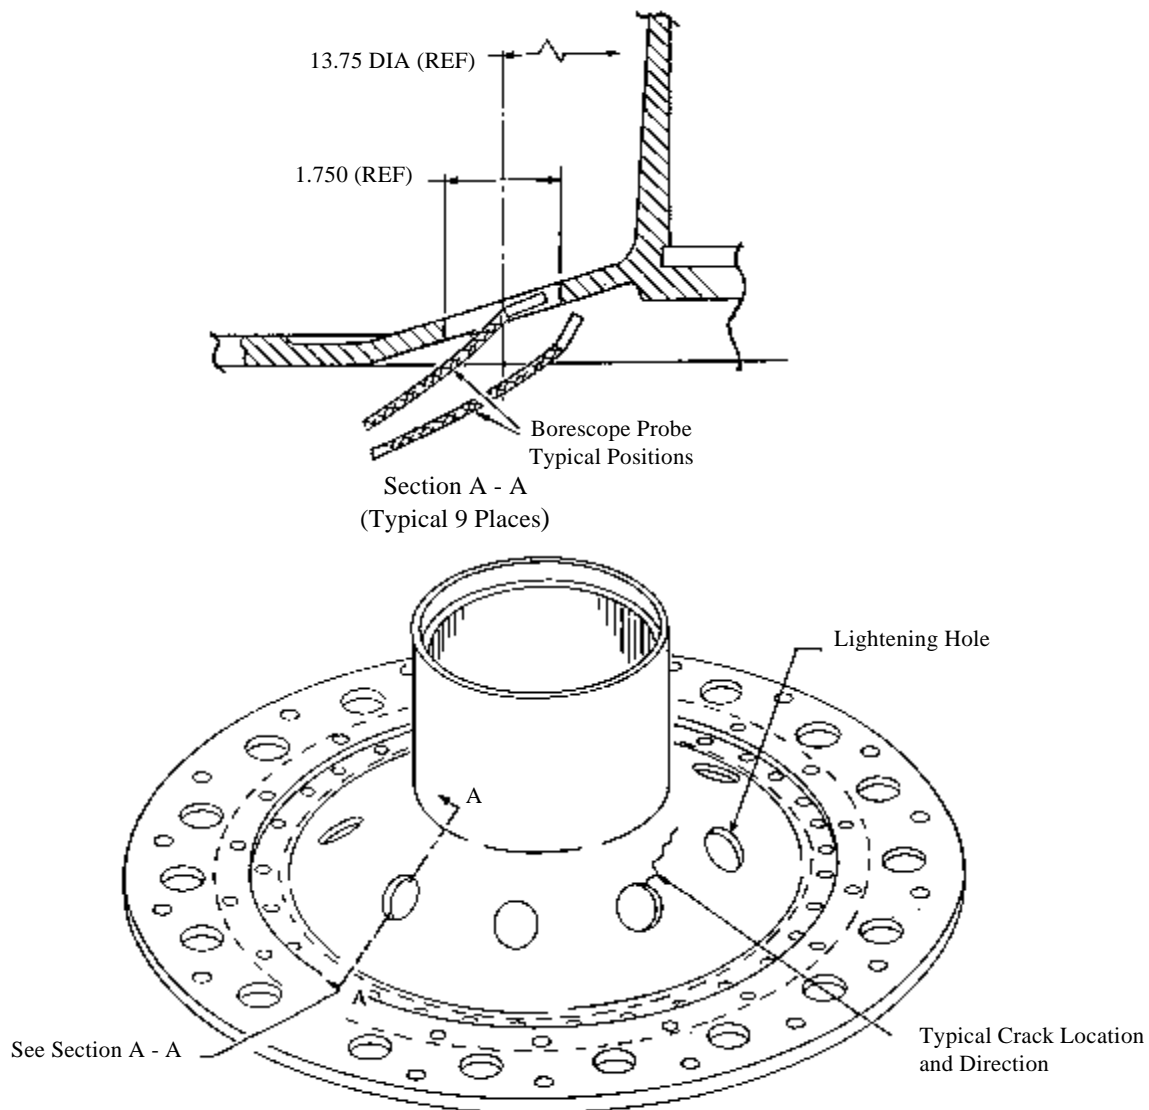
Borescope Inspection of
Second Stage Lower Planetary Plate
Figure 2

(1) Inspect the plate for a crack in the area around all nine lightening holes using a Borescope or equivalent inspection method (see Figure 2).

(2) If a crack is found, replace the plate with an airworthy plate.
